Manhole Inspection Summary

Manhole # S37EE_059MH

Location Address: **601 BIDDLE ST**

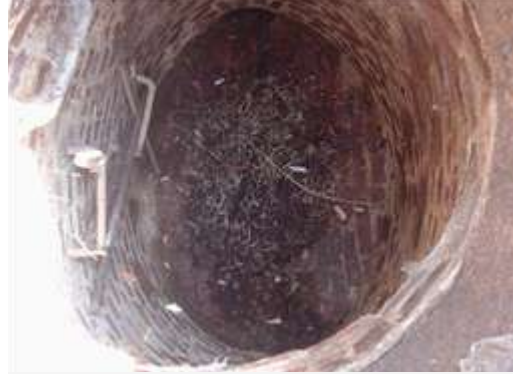
Top View

Infiltration: ☐ None ☐ Joint ☐ Cracks ☒ **Mortar** ☐ Roots ☒ **Wall**

Channel Material: **Brick** ☐ Parged ☒ **Debris** (not Condition related)

Barrel infiltration. Channel debris.

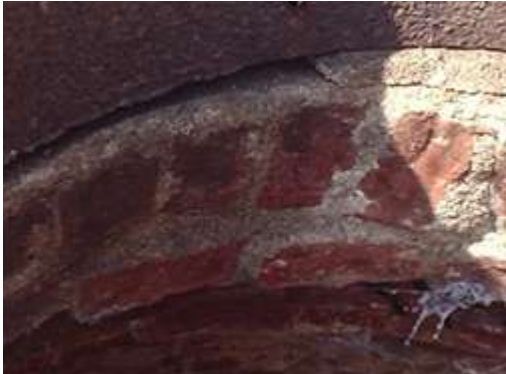
Defect

Condition: ☐ Sound ☐ Cracked ☐ Root Intrusion ☐ Loose Brick ☒ **Deteriorated**

Infiltration: ☐ None ☒ **Joint** ☐ Cracks ☐ Mortar ☐ Roots ☐ Wall

Adjustment deterioration and infiltration.

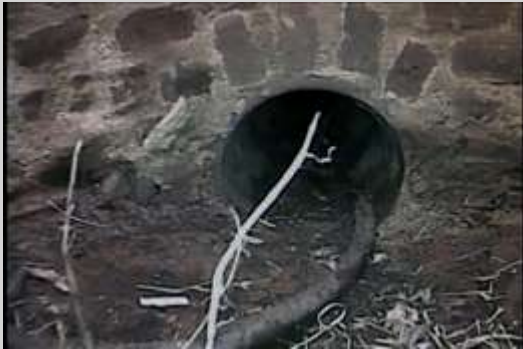
8 in. Circular Gravity Sewer
Pipe Out @ 12 O'Clock

Deposits: ☐ None ☒ **Mud** ☐ Sludge ☒ **Debris** ☐ Grease

Silt Depth: **0.5** (in.) Deposits Extent: **Light**
